**Flood Control Project Maintenance
Levee Inspections****LMA District Cover Sheet****Spring 2016 Levee Inspection Results****Sutter Maintenance Yard Tisdale Bypass**

Spring 2016 Levee Inspection Results

Sutter Maintenance Yard Tisdale Bypass

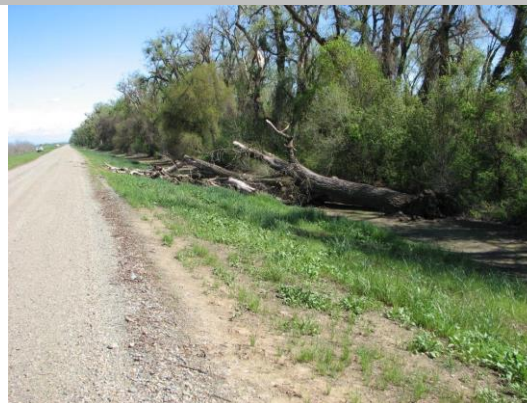
Photo 1 of 1 : SP_2016_ST0009_286_7_20160405_00004.jpg

LM Start	0.40	Rating **	U	Issue No.	7
LM End	0.40	Issue Type +	Ma	Location *	WS
Category	Earthen Levee			GPS Latitude/Longitude	
				Start	End
Item	Vegetation			39.028427 °	39.028427 °
				-121.814699 °	-121.814699 °
DWR ID	DWR_ST0009_01_s_2016_7				
Comment Code					
V7 : Trees / Woody Vegetation					
Inspector Comment					
Recently fallen Cottonwood obscuring waterside levee slope.

Downed tree obstructing access

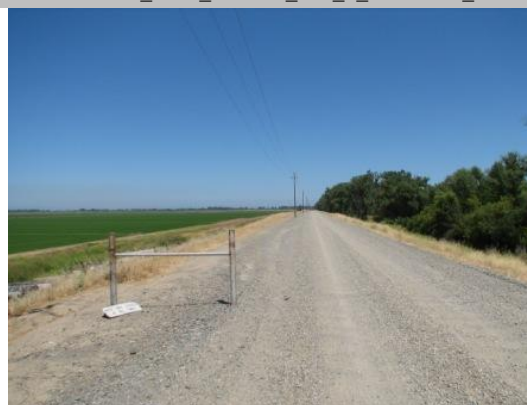
Photo 1 of 1 : SP_2016_ST0009_286_3_20160316_00001.jpg

LM Start	2.19	Rating **	M	Issue No.	3
LM End	4.11	Issue Type +	En	Location *	LS
Category	Earthen Levee			GPS Latitude/Longitude	
				Start	End
Item	Encroachments			39.028173 °	39.028012 °
				-121.781475 °	-121.745665 °
DWR ID	DWR_ST0009_01_s_2012_3				
Comment Code					
PO : Pole					
Inspector Comment

View of the PG&E poles along the landside crown of the levee.

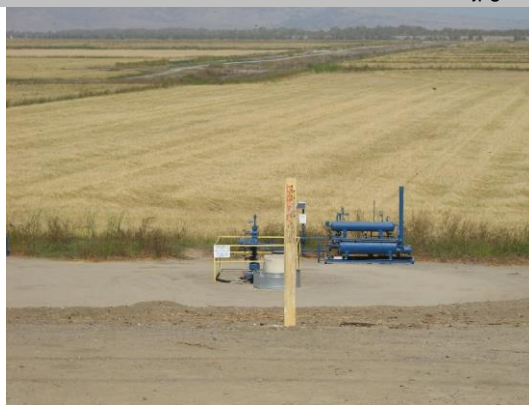
Photo 1 of 1 : UCIP_SP_2016_48379_64220.jpg

LM Start	3.65	Rating **	M	Issue No.	10
LM End	3.65	Issue Type +	En	Location *	WS
Category	Supplemental			GPS Latitude/Longitude	
				Start	End
Item	DWR UCIP Field Study			39.027911 °	39.027911 °
				-121.754224 °	-121.754224 °
DWR ID

Comment Code					
Inspector Comment					
FS_ID:48379 DS_ID:16590 EP_NO: 14740 Repair Type: Non-Urgent Crossing Status: Indicator Found UCIP Comments: 4/18/2016 Carsonite marker on WS shoulder is missing.5/7/2015 Marker on WS shoulder missing.11/13/2014 Same as last inspection.5/12/2014 Same as last inspection.10/30/2013 Same as last inspection.5/20/2013 Carsonite marker on WS shoulder missing and should be replaced. FIELD_STRUCT_DESC: 4-inch pipe through levee and under channel, 2.5 feet below crown. Carsonite signs on both landside (LS) and waterside (WS) shoulder. Gas Wells 200-feet off of LS toe. Drawings available. (Permit No. 14740, 1988-Nahama and Weagant Energy Co.) [Additional Reference(s): DWR Levee Log, 1993] FS Date: 4/22/2016 1:11:00 PM

Carsonite sign on LS shoulder with view of gas well in background.

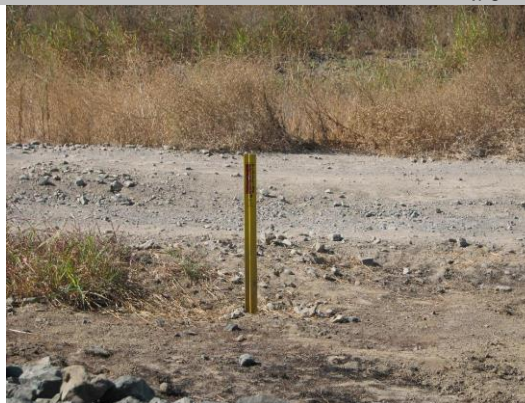
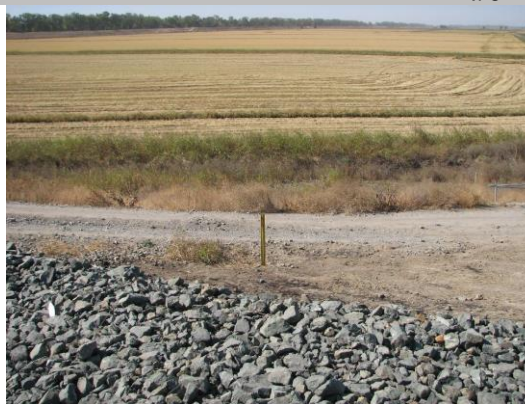
LM Start	4.50	Rating **	M	Issue No.	11
LM End	4.50	Issue Type +	En	Location *	WS
Category	Supplemental			GPS Latitude/Longitude	
				Start	End
Item	DWR UCIP Field Study			39.032801 °	39.032801 °
				-121.743360 °	-121.743360 °
DWR ID

Comment Code					
Inspector Comment					
FS_ID:48384					
DS_ID:16855					
EP_NO: 14455					
Repair Type: Non-Urgent					
Crossing Status: Indicator Found					
UCIP Comments: 4/18/2016 Carsonite marker on LS slope is broke					
off.5/7/2015 Crossing is in good condition. No noticeable issues to					
report.11/13/2014 Same as last inspection.5/12/2014 Same as last					
inspection.10/30/2013 Same as last inspection.5/20/2013 Same as					
last inspection.					
FIELD_STRUCT_DESC: 1 of 2: 4-1/2-inch steel natural gas pipeline					
through levee, 2 feet below crown. Line goes across the Sutter Bypass					
and through both levees. Carsonite sign on landside (LS) slope.					
Drawings are available. (Permit No. 14455, 1986-Depco Inc.)					
[Additional Reference(s): DWR Levee Log, 1993]					
FS Date: 4/22/2016 1:13:00 PM

Carsonite sign on LS slope.

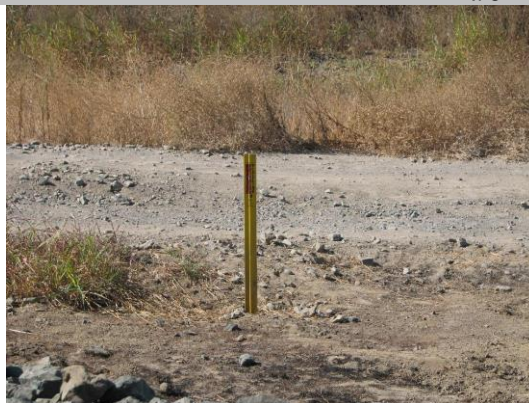
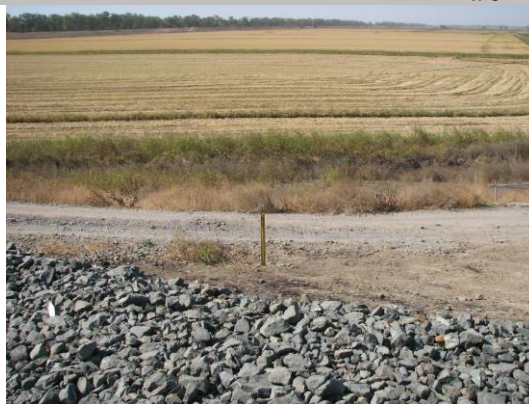
LM Start	4.50	Rating **	M	Issue No.	9
LM End	4.50	Issue Type +	En	Location *	WS
Category	Supplemental			GPS Latitude/Longitude	
				Start	End
Item	DWR UCIP Field Study			39.032801 °	39.032801 °
				-121.743360 °	-121.743360 °
DWR ID

Comment Code					
Inspector Comment					
FS_ID:48378 DS_ID:16589 EP_NO: 14455 Repair Type: Non-Urgent Crossing Status: Indicator Found UCIP Comments: 4/18/2016 Craosnite marker on LS slope is broken off.5/7/2015 Crossing is in good condition. No noticeable issues to report.11/13/2014 Same as last inspection.5/12/2014 Same as last inspection.10/30/2013 Same as last inspection.5/20/2013 Same as last inspection. FIELD_STRUCT_DESC: 2 of 2: 4-1/2-inch steel natural gas pipeline through levee, 2 feet below crown. Line goes across the Sutter Bypass and through both levees. Carsonite sign on landside (LS) slope. Drawings are available. (Permit No. 14455, 1986-Depco Inc.) FS Date: 4/22/2016 1:14:00 PM

Carsonite sign on LS slope.

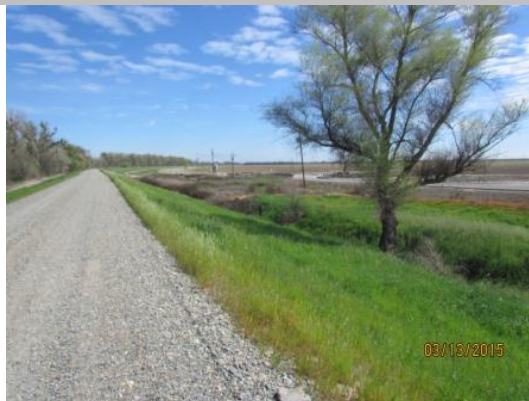
Photo 1 of 1 : SP_2016_ST0009_287_1_20160316_00001.jpg

LM Start	0.11	Rating **	M	Issue No.	1
LM End	0.26	Issue Type +	En	Location *	LS
Category	Earthen Levee			GPS Latitude/Longitude	
				Start	End
Item	Encroachments			39.023760 °	39.024559 °
				-121.818875 °	-121.816344 °
DWR ID	DWR_ST0009_02_s_2012_1				
Comment Code					
DT : Ditch					
Inspector Comment					
Monitor the ditch for erosion.

View of the agricultural ditch along the landside toe.

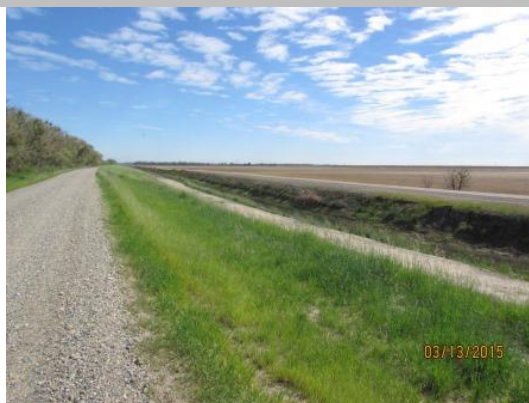
Photo 1 of 1 : SP_2016_ST0009_287_2_20160316_00002.jpg

LM Start	0.52	Rating **	M	Issue No.	2
LM End	1.74	Issue Type +	En	Location *	LS
Category	Earthen Levee			GPS Latitude/Longitude	
				Start	End
Item	Encroachments			39.025539 °	39.025398 °
				-121.811540 °	-121.789006 °
DWR ID	DWR_ST0009_02_s_2012_2				
Comment Code					
DT : Ditch					
Inspector Comment					
Monitor the ditch for erosion.

View of the agriculture ditch next to the landside toe.

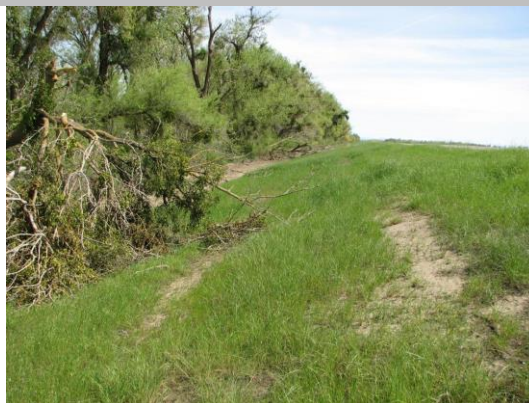
Photo 1 of 1 : SP_2016_ST0009_287_8_20160405_00013.jpg

LM Start	0.58	Rating **	M	Issue No.	8
LM End	0.58	Issue Type +	Ma	Location *	WS
Category	Earthen Levee			GPS Latitude/Longitude	
				Start	End
Item	Trim / Thin Trees			39.025582 °	39.025582 °
				-121.810568 °	-121.810568 °
DWR ID	DWR_ST0009_02_s_2016_8				
Comment Code					
T3 : Trim and thin trees to allow visibility of the ground and room to flood fight.					
Inspector Comment					
Couple of downed trees obscuring waterside slope.

Downed tree limb obstructing access

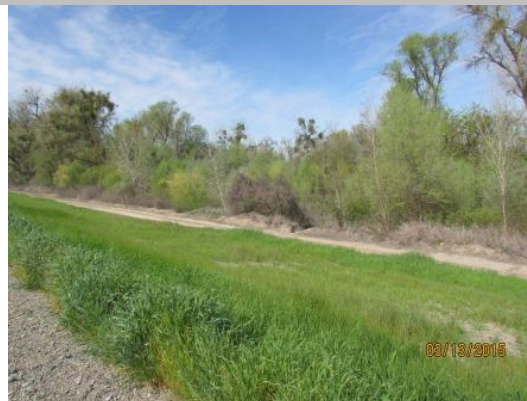
Photo 1 of 1 : SP_2016_ST0009_287_3_20160316_00003.jpg

LM Start	1.01	Rating **	M	Issue No.	3
LM End	1.01	Issue Type +	Ma	Location *	WS
Category	Earthen Levee			GPS Latitude/Longitude	
				Start	End
Item	Erosion / Bank Caving			39.025542 °	39.025542 °
				-121.802468 °	-121.802468 °
DWR ID	DWR_ST0009_02_s_2012_3				
Comment Code					
E1 : Note and monitor erosion site.					
Inspector Comment					
Sutter Yard needs to monitor the erosion.

View of the erosion along the waterside berm.

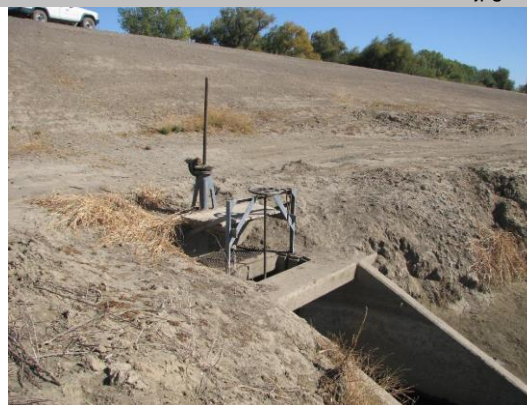
Photo 1 of 2 : UCIP_SP_2016_48383_64675.jpg

LM Start	1.14	Rating **	M	Issue No.	291
LM End	1.14	Issue Type +	En	Location *	WS
Category	Supplemental			GPS Latitude/Longitude	
				Start	End
Item	DWR UCIP Field Study			39.025503 °	39.025503 °
				-121.800053 °	-121.800053 °
DWR ID

Comment Code					
Inspector Comment					
FS_ID:48383 DS_ID:16594 EP_NO: 267 Repair Type: Non-Urgent Crossing Status: Found UCIP Comments: 4/18/2016 Erosion happening around the WS concrete vault.5/7/2015 Burrowing near WS toe stil present.11/13/2014 Same as last inspection.5/12/2014 Same as last inspection.10/30/2013 Same as last inspection.5/20/2013 Same as last inspection.10/17/2012 Burrowing along downstream side of concrete vault on WS Toe. May need to be grouted. FIELD_STRUCT_DESC: 54-inch concrete irrigation pipe through levee, 29.5 feet below the crown. Slide gates on both waterside (WS) and landside (LS) ends. WS end gate in 5-foot by 6-foot concrete box. LS end gate in concrete "U" headwall. Siphon pipe under and across bypass, steel concrete encased. (Permit No. 267 & 290 - Sutter Basin Water Co.) [Additional Reference(s): DWR Levee Log, 1993. USACE Sacramento O&M Manual 129, August 1955 (Station 61+25)]. FS Date: 4/22/2016 1:06:00 PM

Slide gate at concrete outlet on LS toe.

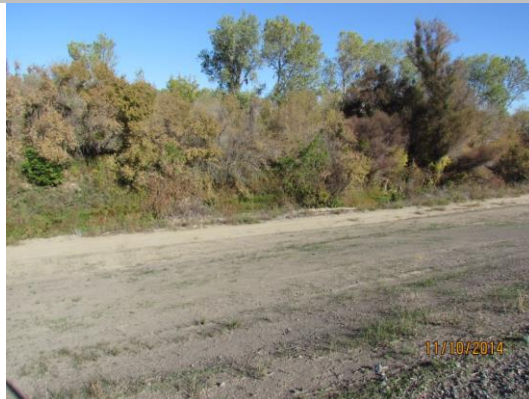
Photo 1 of 1 : SP_2016_ST0009_287_4_20160316_00004.jpg

LM Start	1.29	Rating **	M	Issue No.	4
LM End	1.29	Issue Type +	Ma	Location *	WS
Category	Earthen Levee			GPS Latitude/Longitude	
				Start	End
Item	Erosion / Bank Caving			39.025478 °	39.025478 °
				-121.797232 °	-121.797232 °
DWR ID	DWR_ST0009_02_s_2013_4				
Comment Code					
E2 : Schedule repair of erosion site prior to the next inspection.					
Inspector Comment					
Sutter Yard needs to monitor the erosion.

View of the erosion along the waterside berm.

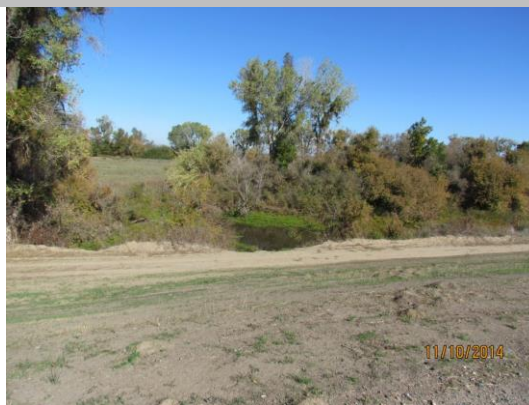
Photo 1 of 1 : SP_2016_ST0009_287_5_20160316_00005.jpg

LM Start	1.50	Rating **	M	Issue No.	5
LM End	1.50	Issue Type +	Ma	Location *	WS
Category	Earthen Levee			GPS Latitude/Longitude	
				Start	End
Item	Erosion / Bank Caving			39.025446 °	39.025446 °
				-121.793347 °	-121.793347 °
DWR ID	DWR_ST0009_02_s_2013_5				
Comment Code					
E2 : Schedule repair of erosion site prior to the next inspection.					
Inspector Comment					
Sutter Yard needs to monitor the erosion.

View of the erosion along the waterside berm.

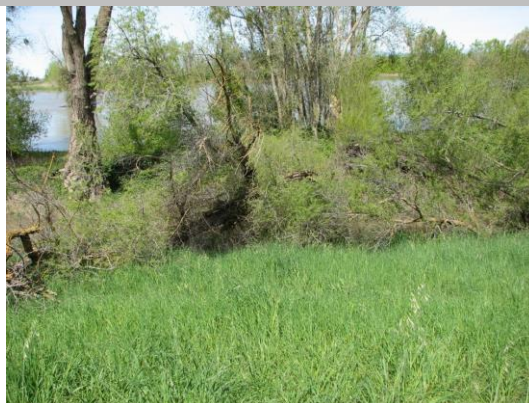
Photo 1 of 1 : SP_2016_ST0009_287_9_20160405_00014.jpg

LM Start	2.18	Rating **	M	Issue No.	9
LM End	2.18	Issue Type +	Ma	Location *	WS
Category	Earthen Levee			GPS Latitude/Longitude	
				Start	End
Item	Trim / Thin Trees			39.025382 °	39.025382 °
				-121.780723 °	-121.780723 °
DWR ID	DWR_ST0009_02_s_2016_9				
Comment Code					
T3 : Trim and thin trees to allow visibility of the ground and room to flood fight.					
Inspector Comment

Downed tree obstructing access

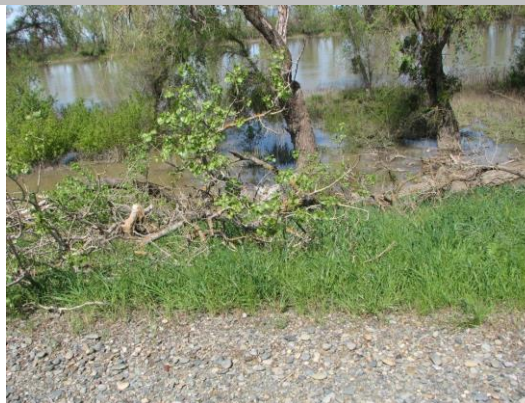
Photo 1 of 1 : SP_2016_ST0009_287_10_20160405_00015.jpg

LM Start	2.29	Rating **	M	Issue No.	10
LM End	2.29	Issue Type +	Ma	Location *	WS
Category	Earthen Levee			GPS Latitude/Longitude	
				Start	End
Item	Trim / Thin Trees			39.025386 °	39.025386 °
				-121.778787 °	-121.778787 °
DWR ID	DWR_ST0009_02_s_2016_10				
Comment Code					
T3 : Trim and thin trees to allow visibility of the ground and room to flood fight.					
Inspector Comment					
Fallen tree on WS slope.

Downed tree limb obstructing access

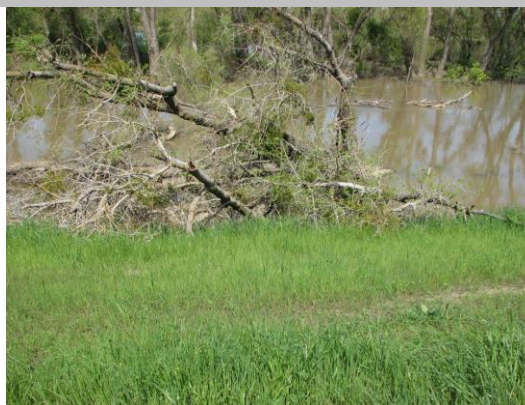
Photo 1 of 1 : SP_2016_ST0009_287_11_20160405_00016.jpg

LM Start	2.66	Rating **	M	Issue No.	11
LM End	2.66	Issue Type +	Ma	Location *	WS
Category	Earthen Levee			GPS Latitude/Longitude	
				Start	End
Item	Trim / Thin Trees			39.025303 °	39.025303 °
				-121.771867 °	-121.771867 °
DWR ID	DWR_ST0009_02_s_2016_11				
Comment Code					
T3 : Trim and thin trees to allow visibility of the ground and room to flood fight.					
Inspector Comment					
Fallen tree obscuring waterside slope.

Downed tree obstructing access

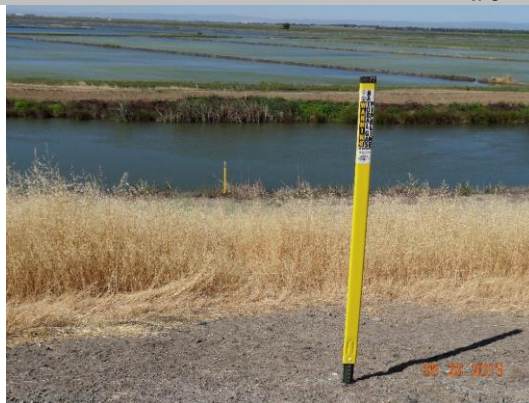
Photo 1 of 2 : UCIP_SP_2016_48386_64681.jpg

Comment Code					
Inspector Comment					
FS_ID:48386 DS_ID:23099 EP_NO: N/A Repair Type: Non-Urgent Crossing Status: Found UCIP Comments: 4/18/2016 Crossing appears to be in good condition. No noticeable issues to report.5/7/2015 Crossing is in good condition. No noticeable issues to report.11/13/2014 Same as last inspection.5/12/2014 Same as last inspection.10/30/2013 Same as last inspection.10/17/2012 Need to identify permit for crossing. FIELD_STRUCT_DESC: Unknown size natural gas pipeline through the levee at an unknown depth. Markers visible on landside (LS) shoulder and toe and waterside (WS) shoulder and toe. No photos available. No permit has been identified since crossing was field discovered in 2012. FS Date: 4/22/2016 1:12:00 PM

Marker on LS shoulder and toe

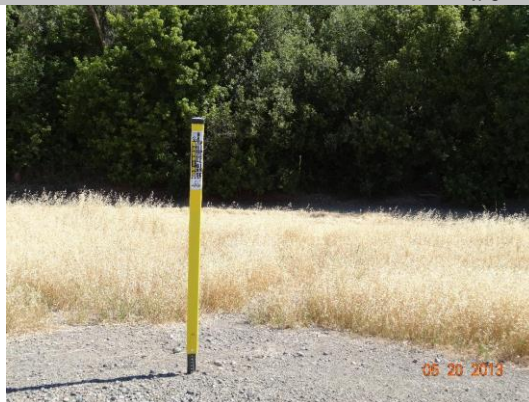
Photo 2 of 2 : UCIP_SP_2016_48386_64680.jpg

Marker on WS shoulder
